INITIATION AND DISTRIBUTION OF MULTIPLE-SITE DAMAGE (MSD) IN A FUSELAGE LAP JOINT CURVED PANEL

Abstract

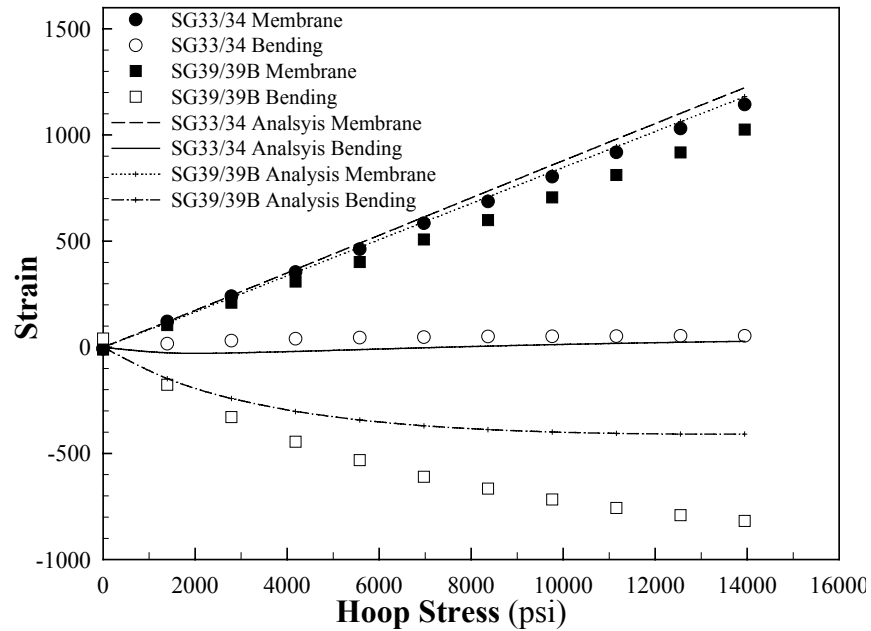
It can be seen that the membrane strain components at both gage set locations differ slightly from each other. The bending strain component of gage set 33/34 is negligible, implying that the deformation in the midbay area is primarily in-plane. On the other hand, the results of gage set 39/39B indicate that a significant amount of local bending occurs near the lap joint area along rivet row A. Since ε_b has a negative value, the local bending in the lap joint area would produce very high tensile stress on the skin inner surface. This may explain why cracks normally initiate at the inner surface of the skin and propagate outward. Also shown in the figure are the finite element predictions, which are generally in good agreement with the experimental results.

Figure 6. Comparison of membrane and bending strain components measured in the skin midbay (SG33/34) and at rivet row A (SG39/39B). Also shown are FEM analysis predictions

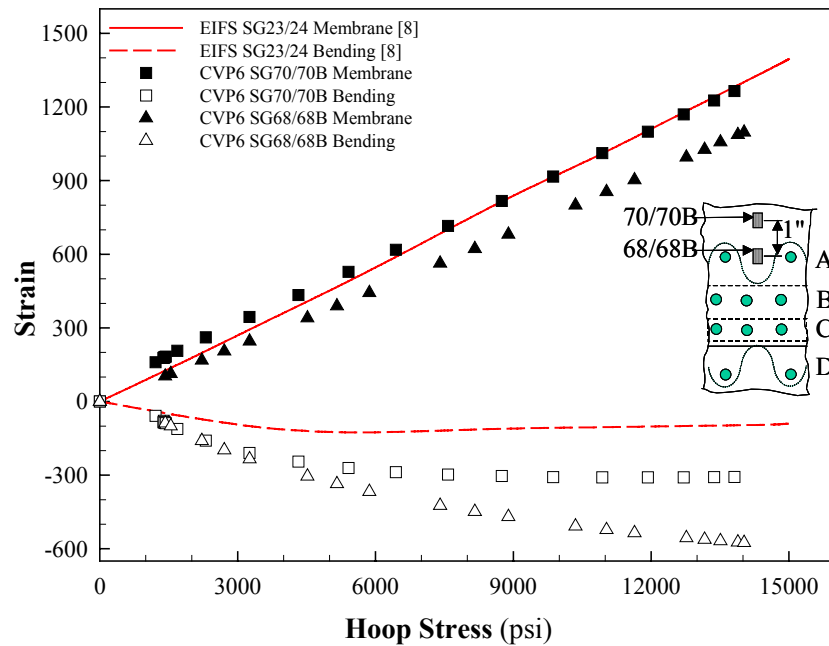
Figure 7 compares the membrane and bending strain components measured at two other back-to-back gage sets, 68/68B and 70/70B, both in bay 2 of the curved panel, and those from a study on a flat panel with a similar lap joint configuration [8]. The gages in the flat panel study had been installed at the same location, relative to the lap joint, as gage set 70/70B shown in the figure. The comparisons clearly indicate that a higher bending strain is seen along rivet row A, and that the local bending effect at the lap joint in the curved panel is more than that in the flat panel. It is the local bending that causes MSD cracks to initiate at the rivet holes along rivet row A.

Figure 7. Comparison of the strains measured at the lap joint in the curved panel and in a flat panel

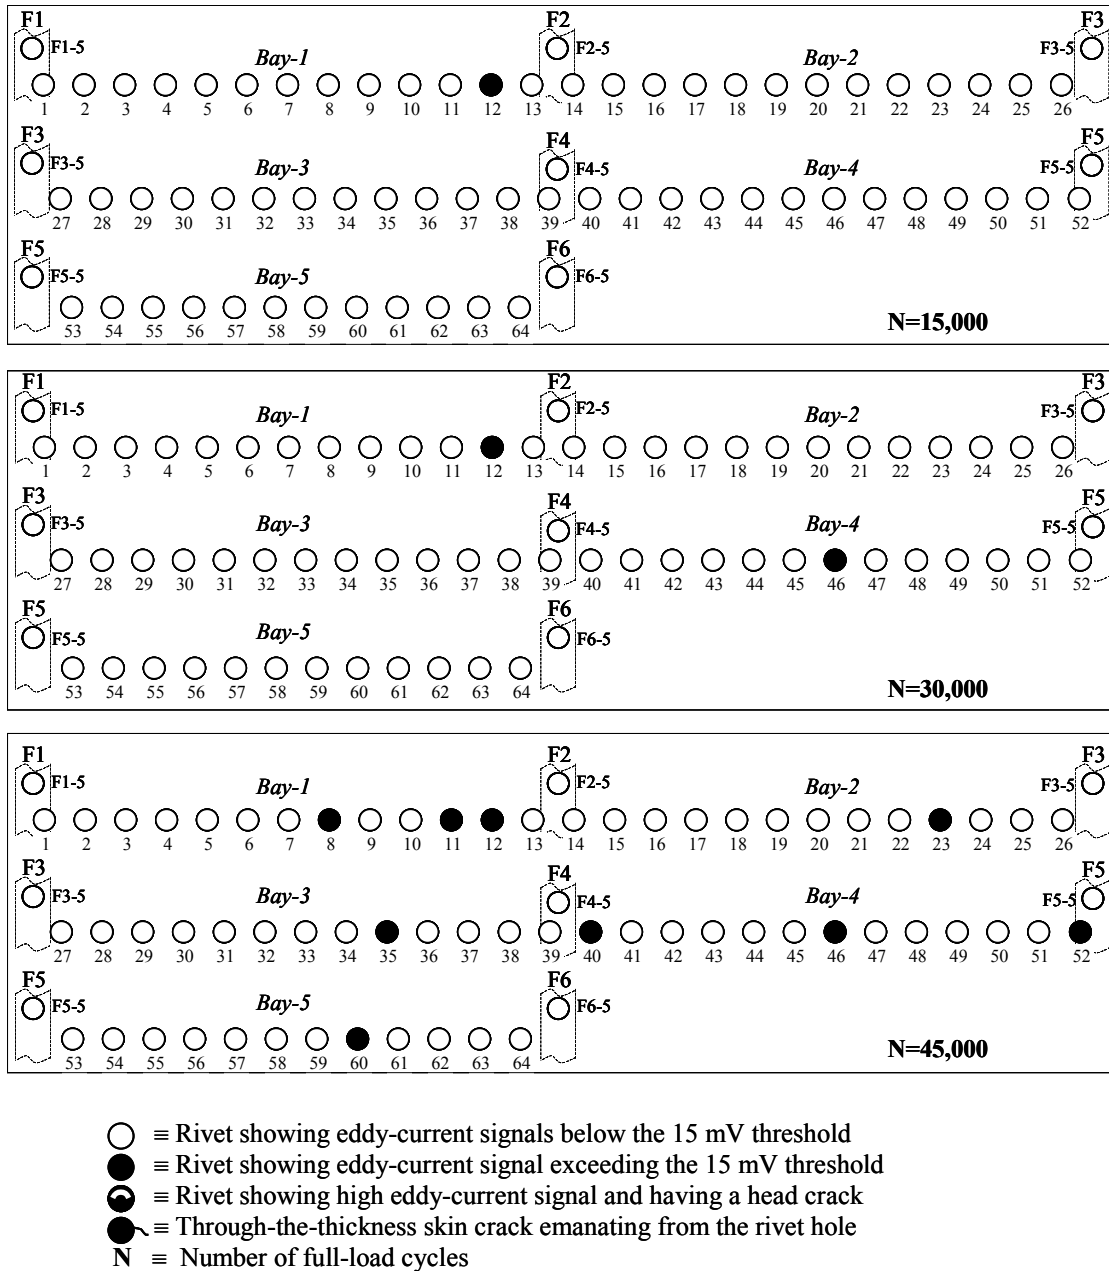
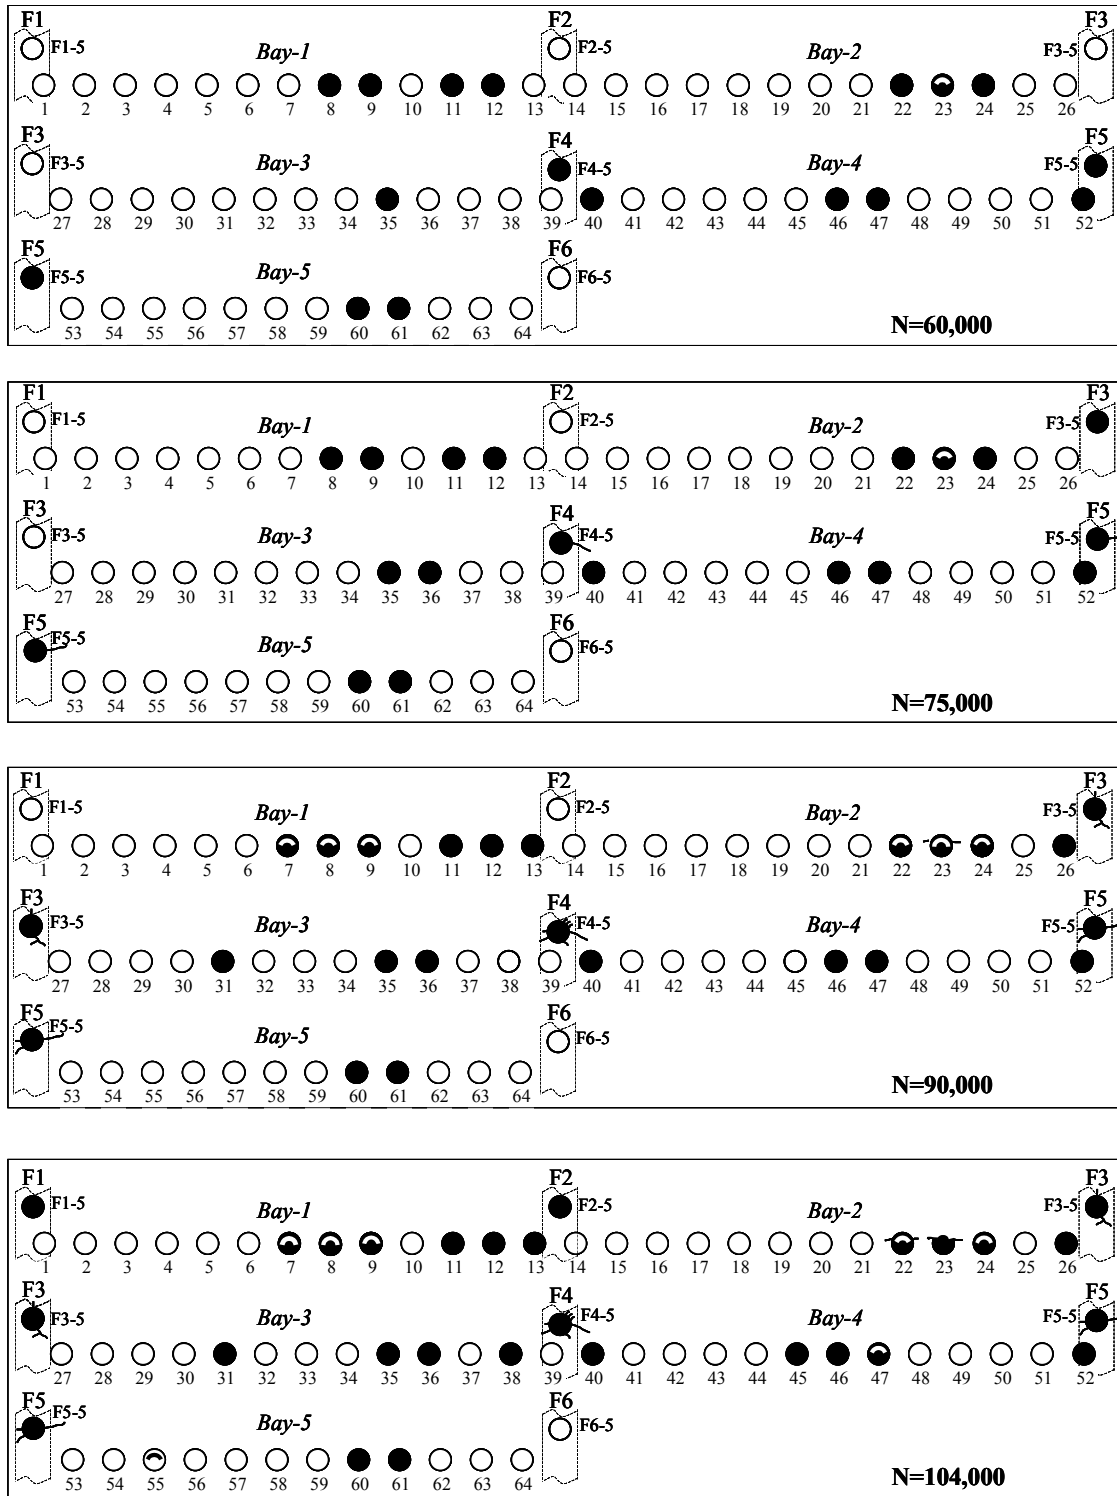
As of this writing, the panel has been subjected to 104,000 full-load (16 psi) fatigue cycles. Most of the high eddy-current signal rivets were in rivet row A. High signals were also obtained from the critical shear clip rivets nearest rivet row A. Visible damage was detected at some of the high eddy-current signal rivets. Figure 8 schematically shows the change in the eddy-current signal and the visible damage evolution in rivet row A and the critical shear clip rivets every 15,000 full-load cycles. In the figure, F1 through F6 denote the locations of the six frames, and F1-5 through F6-5 denote the six critical shear clip rivets. The five bays include 64 rivets in row A. Each block in Figure 8 shows the five bays separated by the six frames. It can be seen that, after the first 15,000 full-load cycles, only rivet A12 in bay 1 was showing high signals. Rivet A46 in bay 4 showed high signals after 30,000 cycles. A total of nine rivets, 13% of the rivets in row A, showed high signals after 45,000 full-load cycles.

Between 45,000 and 60,000 full-load cycles, two of the critical shear clip rivets, F4-5 and F5-5, started showing high eddy-current signals. A crack in the rivet head of A23 in bay 2 was detected after 51,600 full-load cycles. After about 75,000 full-load cycles, cracks were observed emanating from the rivet holes of the shear clip rivets F4-5 and F5-5. The locations where cracks were visually detected correlated very well with the eddy-current signals. In the meantime, rivet F3-5 was also beginning to show high signals. After 40,000 full-load cycles, 24% of the rivets in row A exhibited high eddy-current signals above the threshold.

Between 75,000 and 90,000 full-load cycles, rivet head cracks similar to that on rivet A23 were observed at five other rivets along rivet row A (all previously recorded high eddy-current signals). Skin cracks have also appeared on both sides of rivet A23, but at a distance from the edge of the rivet hole. These skin cracks propagated in both directions and eventually linked up with the rivet hole. More detailed discussion on these skin cracks will be given later. In addition, two cracks were observed at the rivet hole of the shear clip rivet F3-5, as well as several new cracks at rivets F4-5 and F5-5. After 90,000 full-load cycles, 27% of the rivets in row A exhibited high eddy-current signals above the threshold.

Between 90,000 and 104,000 full-load cycles, high eddy-current signals were detected at more rivets, but the only cracks that were showing appreciable growth were those linked up to rivet hole A23 and the two newly initiated cracks that linked up with rivet hole A22. The cracks at shear clip rivet holes F4-5 and F5-5, although detected first, were growing at a slower rate compared with cracks at rivet row A. It is anticipated that the two cracks propagating towards each other from rivets A22 and A23 will linkup. The fatigue test will be stopped after first crack linkup and the panel will be loaded quasi-statically up to failure to determine its residual strength. After 104,000 full-load cycles, 33% of the rivets in row A exhibited high eddy-current signals above the threshold.

Figure 8. The damage evolution of rivet row A and the critical shear clip rivets as a function of number of full-load cycles

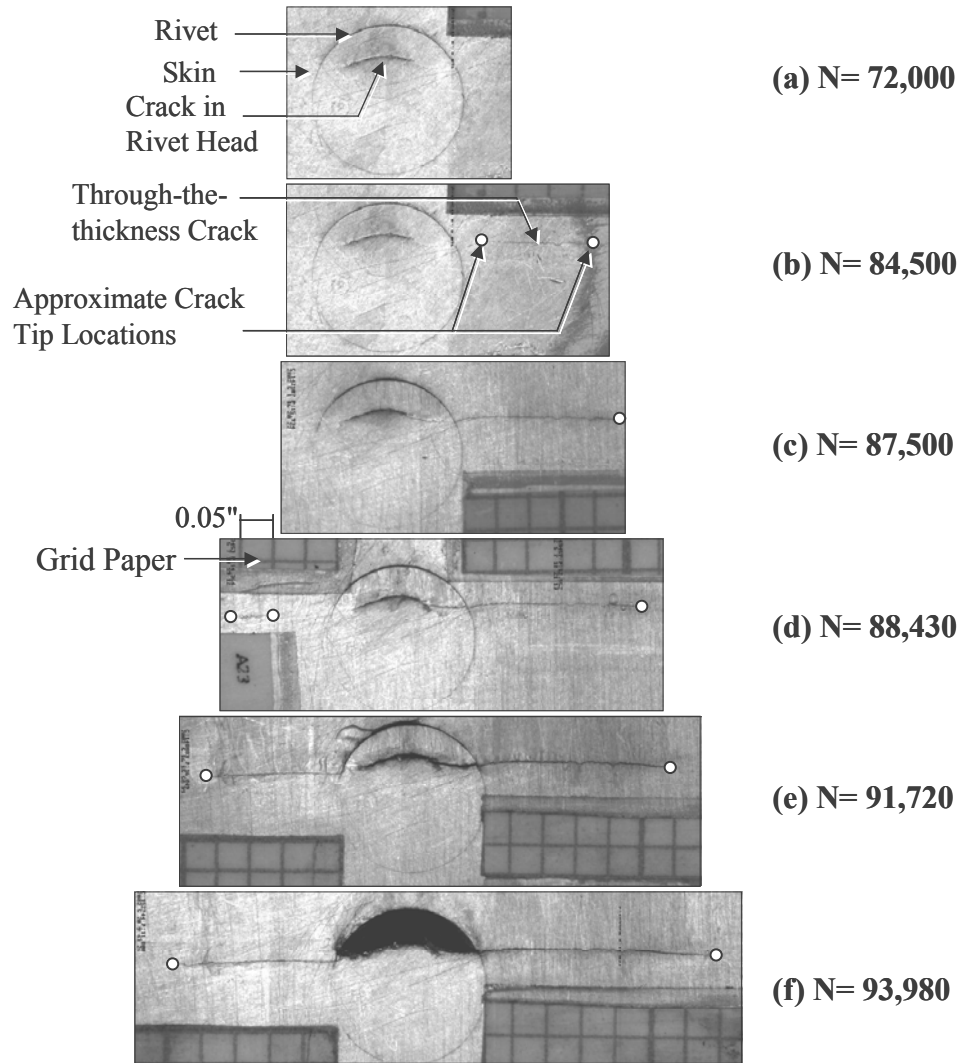
The damage evolution process of rivet A23 is further illustrated in Figure 9 with a series of photographic images taken using the RCCM system. The full-load cycle number at which each image was taken is also shown in the figure. Damage in rivet A23 was first observed in the form of a rivet head crack. Subsequently, the crack grew along a curved path that seemed to follow the perimeter of the rivet stem, Figure 9(a). Water leakage from this crack indicates that it was a through-the-thickness crack. It is noted that the loading used in this study is much higher than what a fuselage would experience during normal service conditions. The rivets are not designed to sustain such high fatigue loads. Thus, it is believed that the rivet head crack initiated at the rivet shank-countersink interface due to the stress concentration in that area and propagated upwards to the surface. As the fatigue test continued, a through-the-thickness crack appeared on the right side of the rivet at a distance from the edge of the rivet hole, Figure 9(b). The through crack grew in both directions and eventually linked up with the rivet hole, Figure 9(c). At a later stage, another through-the-thickness crack appeared on the left side of the rivet, Figure 9(d). This crack also grew in both directions and linked up with the rivet hole, Figure 9(e). Finally, the rivet head crack also propagated to the edge of the rivet hole and joined the other two cracks to form a major crack that cuts through the rivet itself, Figure 9(f). A similar damage evolution process was observed at the neighboring rivet, A22.

Figure 9. RCCM images showing the damage evolution at rivet A23 as a function of number of full-load cycles (N)

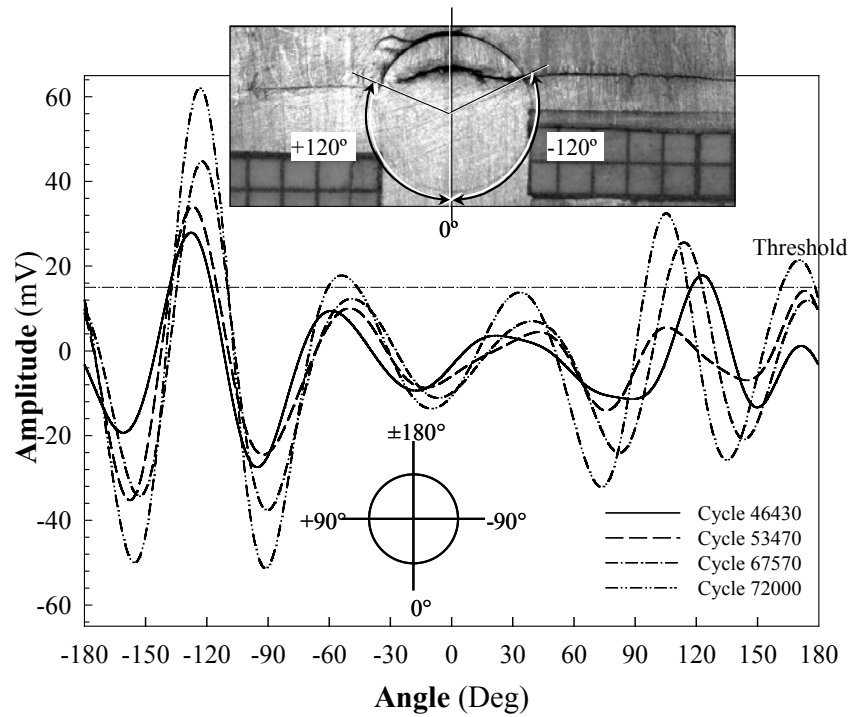
Figure 10 shows the eddy-current inspection results for rivet A23 up to 72,000 full-load cycles, which corresponds to the crack state shown in Figure 9(a). The highest signals were detected at around the -120° location, followed by another high value at around the $+120^\circ$ location. Recall that the first visually detected damage on the skin near rivet A23 was a through-the-thickness crack that occurred on the right side of the rivet, which eventually linked up with the rivet hole of A23 at -120° location. A similar crack was later observed on the left side of the rivet and linked up with the rivet hole at the $+120^\circ$ location. This indicates that the rotating probe system indeed detected hidden cracks initiated under the rivet head. It is plausible to assume that the high residual stress field near the rivet head resulting from the riveting process may have prevented these hidden cracks from propagating through the immediate vicinity of the rivet. This will be investigated through a posttest fractographic study of the crack surfaces and detailed finite element stress analyses.

Figure 10. Eddy-current inspection results for rivet A23

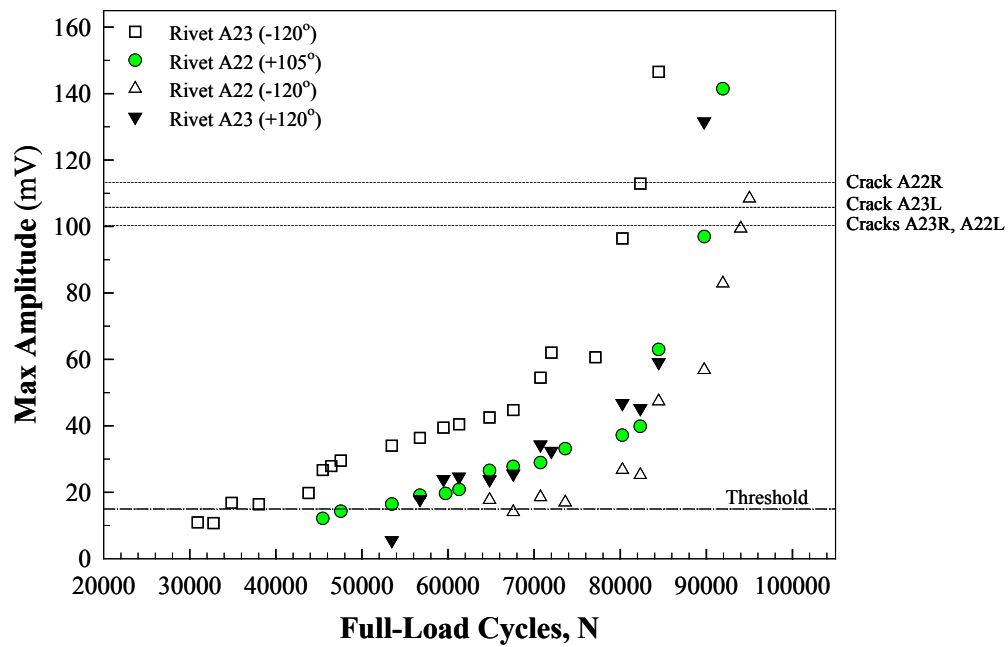
Similar eddy-current inspection results and damage evolution process were observed at rivet A22 where the maximum signals were detected at around the $+105^\circ$ and -120° locations. Figure 11 shows the four maximum amplitudes of eddy-current signals, two each from rivets A22 and A23, as functions of the number of full-load fatigue cycles. The maximum amplitudes at which cracks on the left and right sides of rivets A22 and A23, denoted by A22L, A22R, A23L, and A23R, were first visually detected are also indicated in the figure by horizontal lines. The values of these maximum amplitudes range from 100 to

120 mV. It is noted that the cracks at shear clip rivets F4-5 and F5-5 were first visually detected at eddy-current signal levels of 40 to 50 mV, which are much lower than those at rivets A22 and A23. The type of rivets, the joint configuration, and the local residual stress field are some of the factors that may have contributed to this discrepancy. Further studies are needed to gain a better understanding of the phenomenon.

Figure 11. Eddy-current maximum signal versus number of full-load cycles for rivets A22 and A23

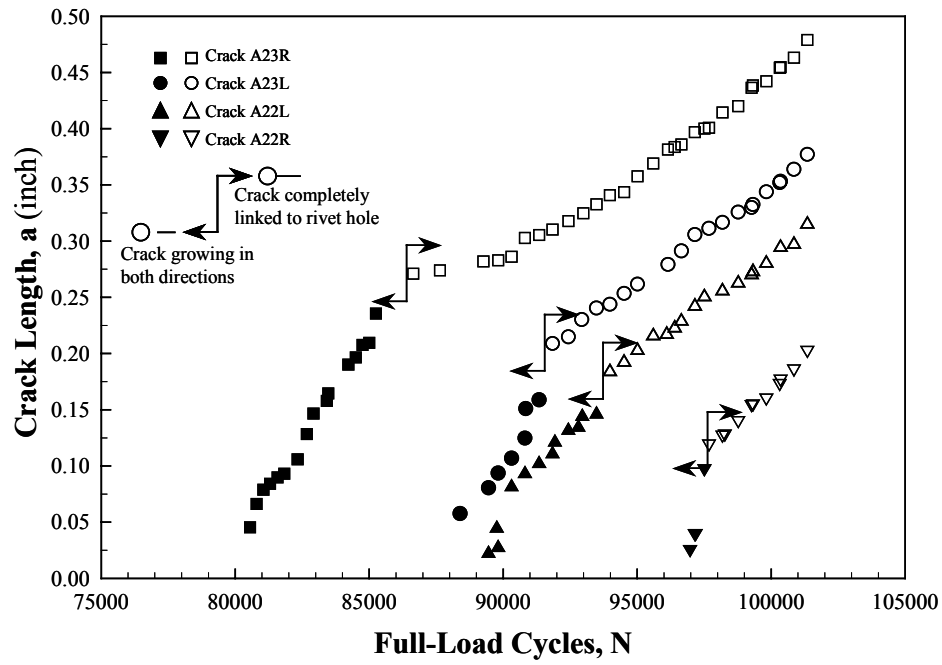
The RCCM system was used to take visual crack length measurements. All measurements were taken while holding the panel at 50% full load. Figure 12 shows the crack length vs number of full-load cycles for the four cracks from the left and right sides of rivets A22 and A23, denoted by A22L, A22R, A23L, and A23R. The solid symbols indicate crack growth prior to linking up with the rivet. The open symbols indicate crack growth after linking up with the rivet. Since each crack grew in both directions before it linked up with the rivet hole, the initial growth rate shown as the solid symbols in Figure 12 appears to be much higher than after the crack grew into the rivet hole shown by the open symbols.

Figure 12. Crack length versus number of full-load cycles for cracks initiated at rivets A22 and A23

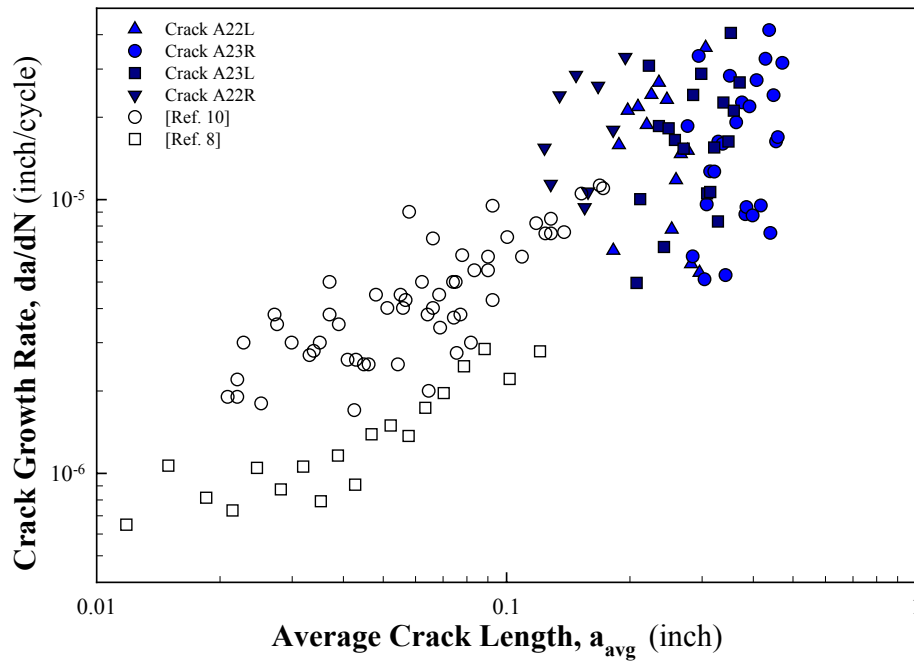
Figure 13 shows the calculated growth rates vs the average crack length for all four cracks after they have linked up with the rivet holes. The average crack length is defined as:

Also shown in the figure are data from a flat panel study [8] and a curved panel test [10]. It can be seen that the results obtained in this study, although for longer crack lengths and different joint and panel configurations, follow the trend of both reference data very well. All the data plotted in Figure 13 shows linear type behavior of crack growth rate as a function of the crack length on a log-log scale. This suggests that the fatigue cracks from these three different studies grew at similar rates. A posttest fractographic study will be conducted to provide data in shorter crack length range for further comparison and verification.

Figure13. Crack growth rates for the lap joint cracks
